K&M Home Inspection

CONFIDENTIAL INSPECTION REPORT

Inspection Address: 3488Grand Teton Dr, Corona, CA 92881
Inspection Date: 8/15/2016 Time: 10:00 am to 12:30 pm
Weather: Clear and Dry - Temperature at time of inspection: 80-90 Degrees
Humidity at time of inspection: 25%

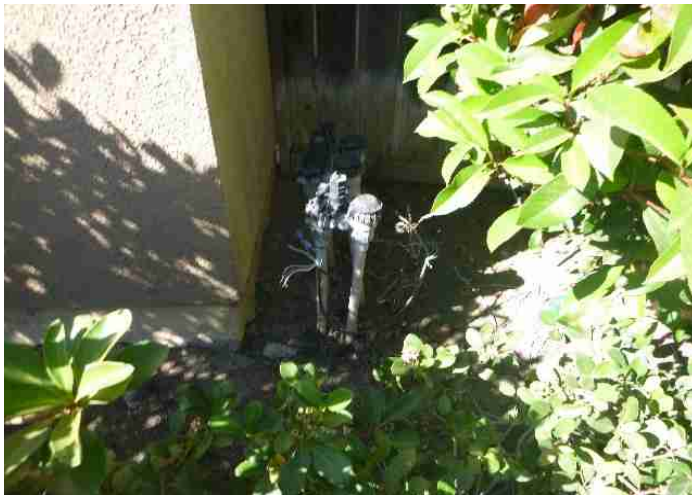
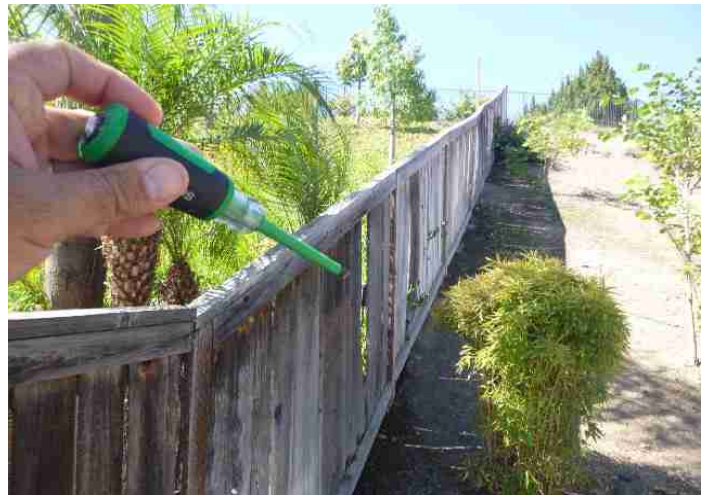
There are trees on this property that we do not have the expertise to evaluate, but which you may wish to have evaluated by an arborist.

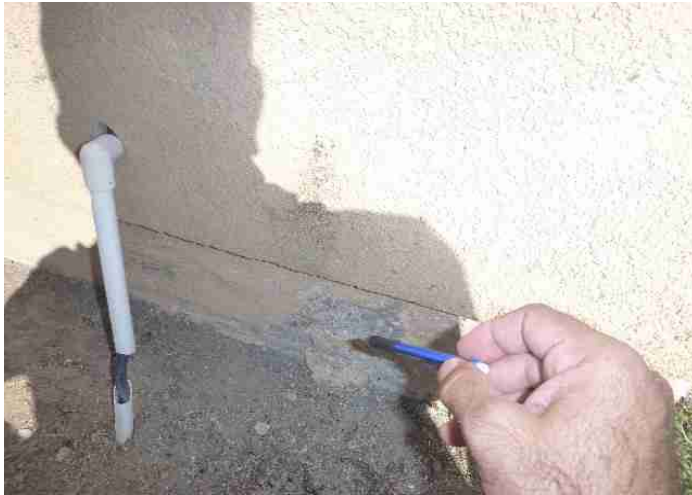
Evidence of moisture in the stucco and should be fixed by a licensed contractor.

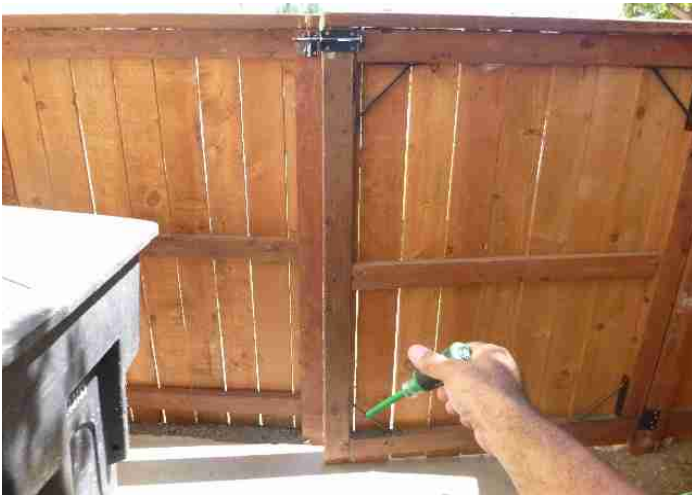
The gates are rubbing on the concrete floor and recommend service

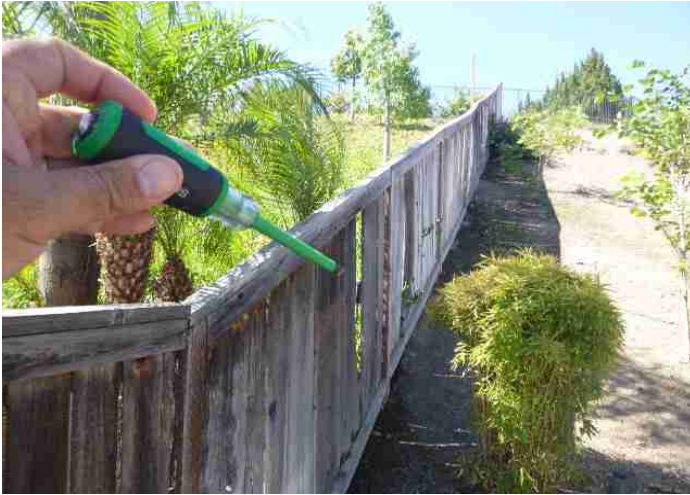
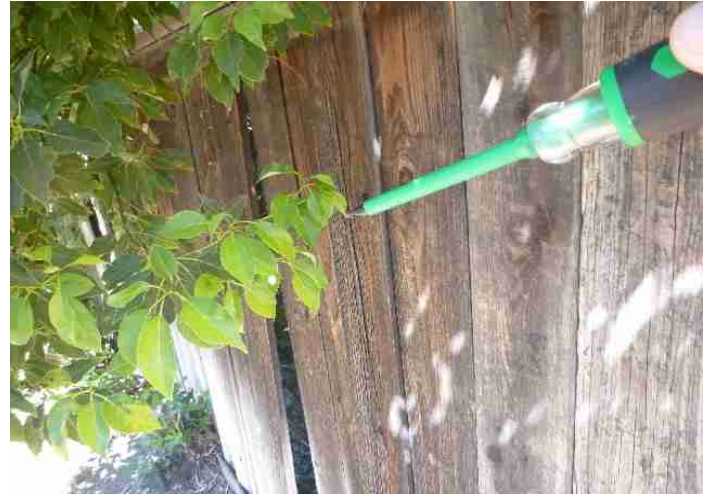
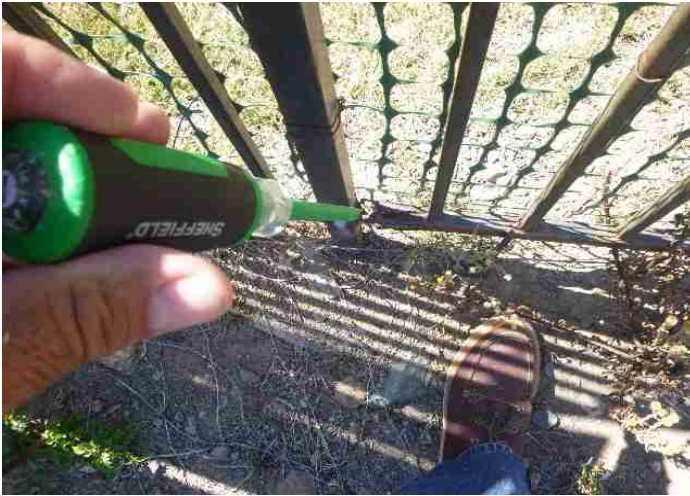
The gates needs typical maintenance-type service, to open and close or latch easily.

Sections of the fence are leaning or damaged and should be repaired or replaced.

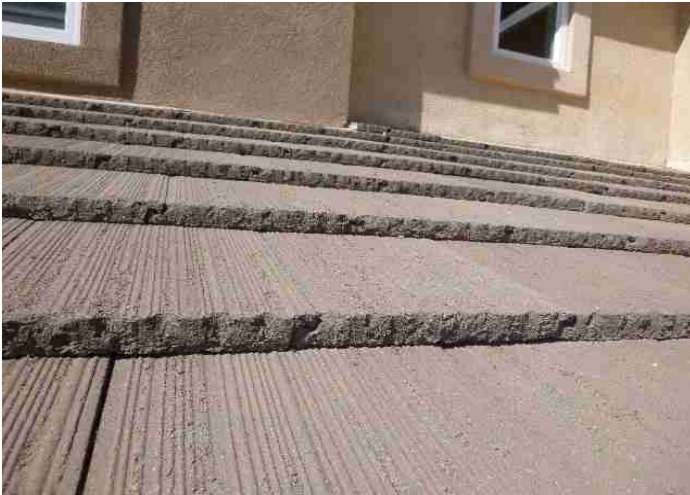
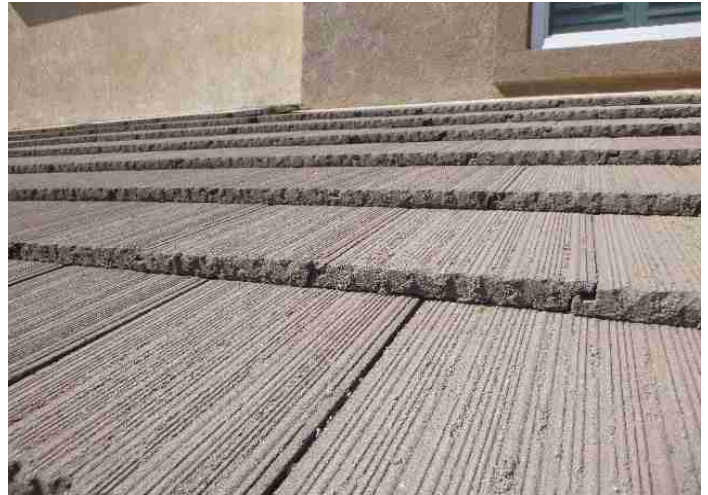
We were unable to access the second-story roof due to its height, and evaluated with the use of binoculars from various vantage points.

We were unable to access the second-story roof due to its height - *Continued*

A licensed roofer is recommended to evaluate the roof.

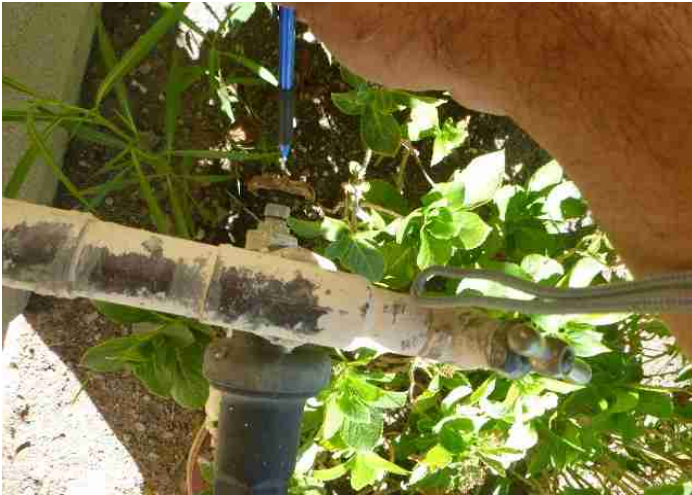
The pressure relief valve at the main is dripping. The regulator should be checked to see if it has failed, or the relief valve should be replaced.

The pressure relief valve at the main is dripping and may need to be replaced - *Continued*

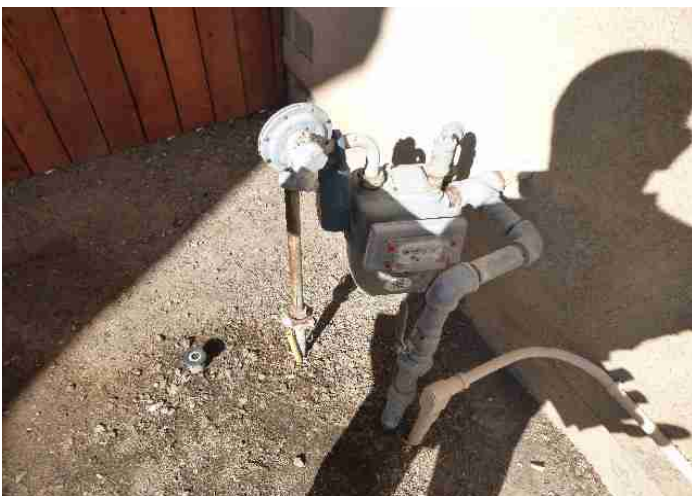
The gas main shut-off is located in the side yard. You should be aware that gas leaks are not uncommon, particularly underground ones, and that they can be difficult to detect without the use of sophisticated instruments, which is why natural gas is odorized in the manufacturing process. Therefore, we recommend that you request a recent gas bill from the sellers, so that you can establish a norm and thereby be alerted to any potential leak.

There is no wrench at the gas shut-off valve to facilitate an emergency shut-off, and inasmuch as such tools are relatively inexpensive we recommend that you buy one and leave it in-place on the valve.

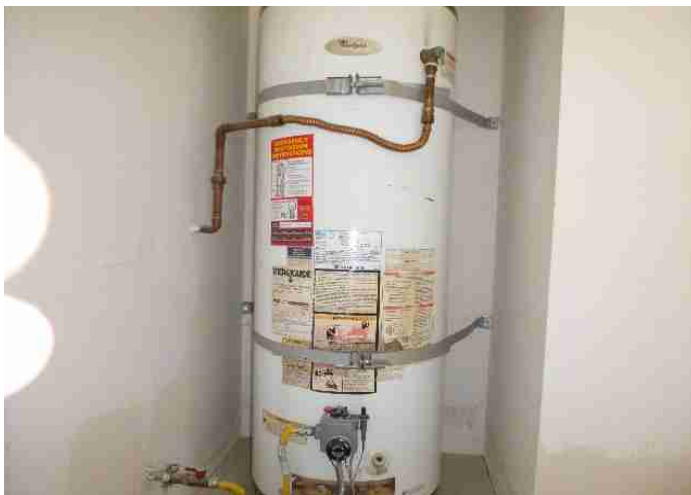
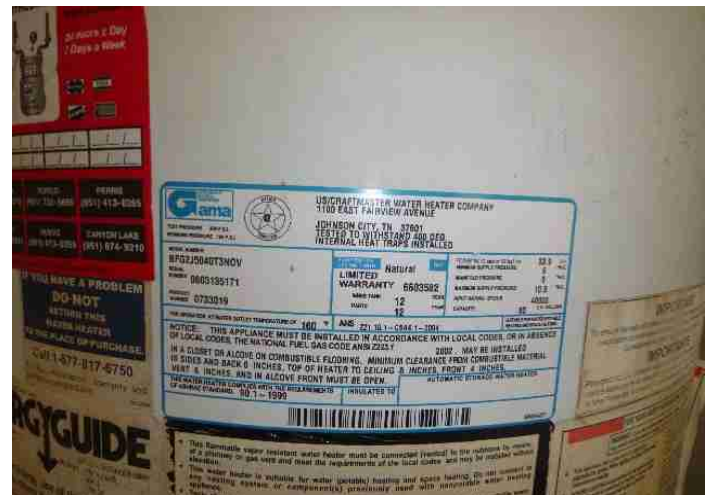
Hot water is provided by a 3 year old, 50 gallon water heater that is located in the garage.

The water heater is not installed over a drain pan and a leak could result in water damage.

The water heater is not equipped with a drain pan and overflow pipe, which is mandated in locations where water could cause structural damage, and should be installed as soon as conveniently possible.

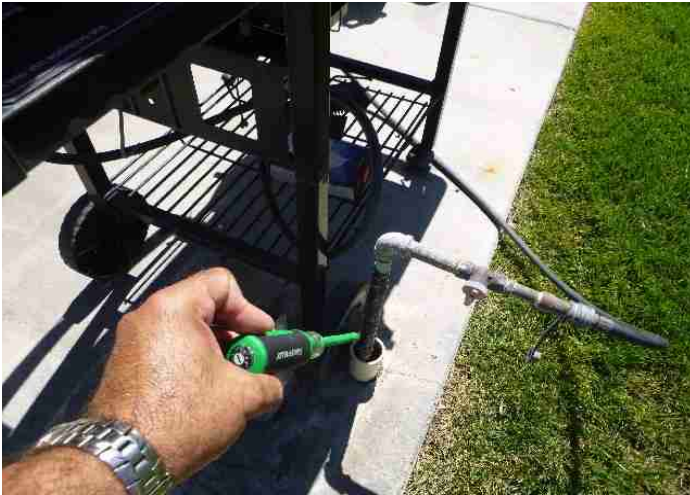
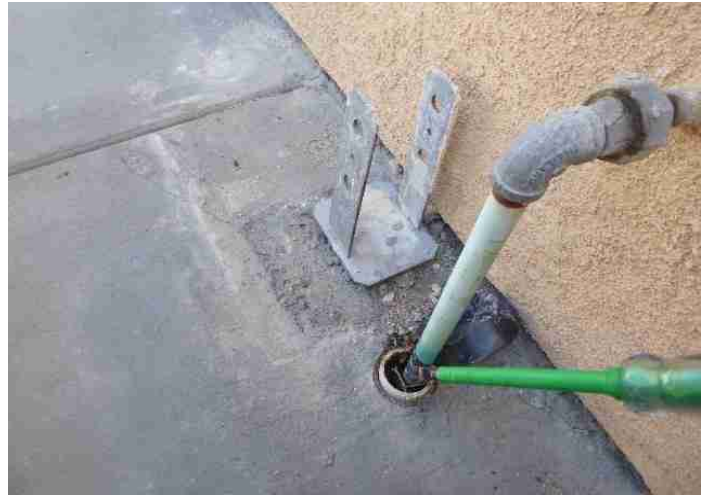
There is possible damage to a gas pipe for the BBQ grill. A licensed plumber is recommended.

There is possible damage to a gas pipe for the BBQ grill - *Continued*

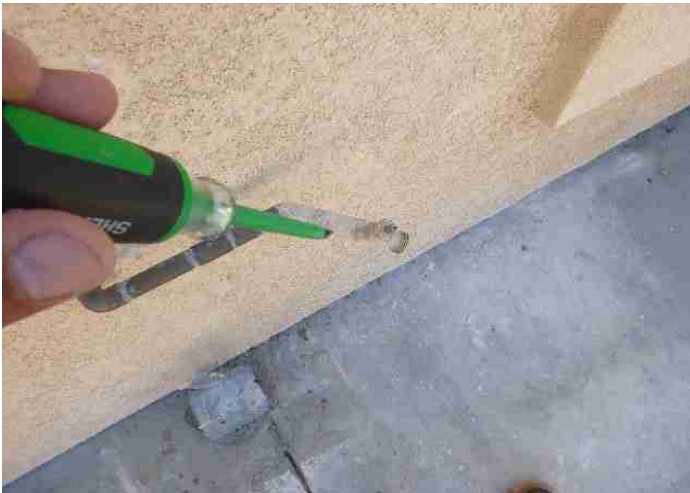
One hose bib is missing its valve and a licensed plumber is recommended.

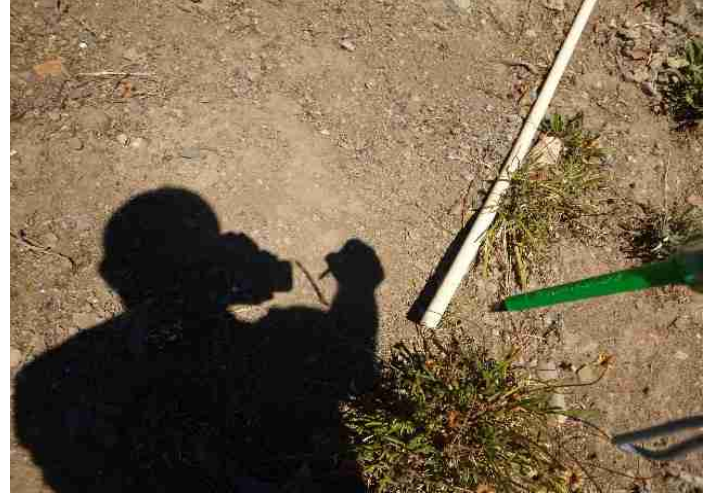
We do not evaluate sprinkler systems but there are several broken pvc pipes broken.

We do not evaluate sprinkler systems but there are several broken PVC pipes broken - *Continued*

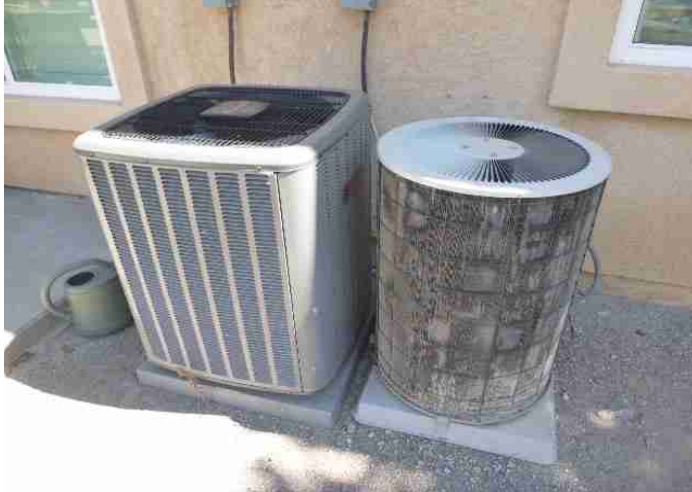
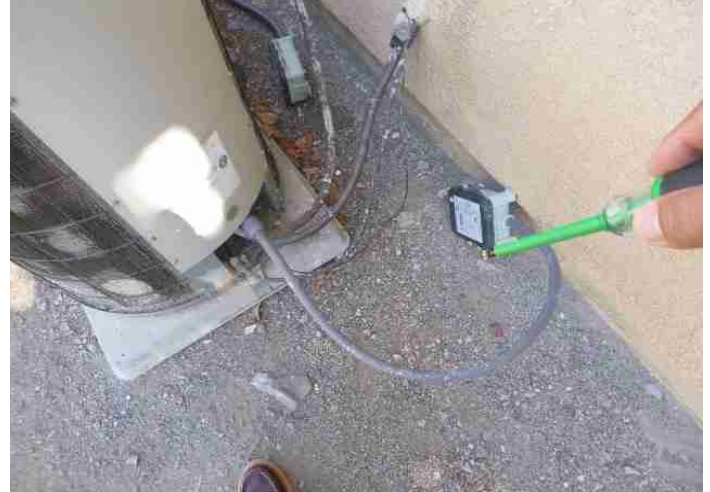
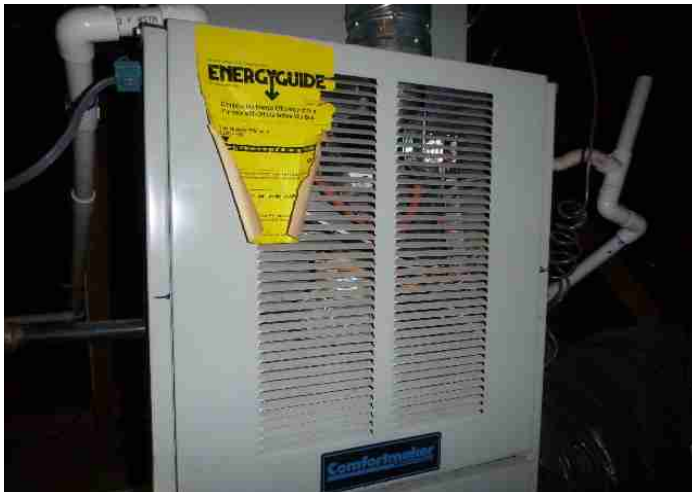
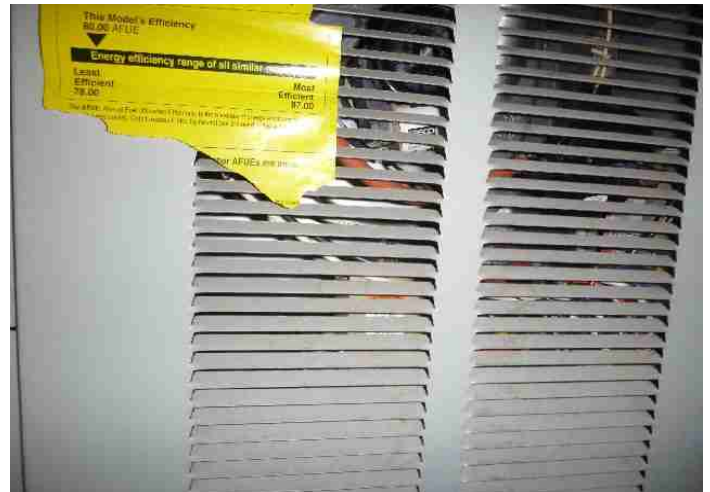
It is recommended the air conditioning and heating be inspected by licensed contractor the gas was off and the heating was not tested the a/c part was tested but would turn on and off we recommended the unit and its componts be inspected by a licensed contractor

It is recommended the filters are changed every 3 to 6 months.

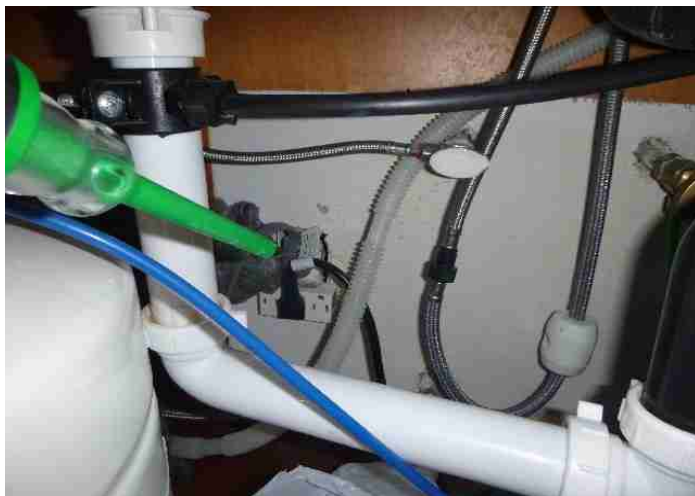
The valves needs to be properly sealed

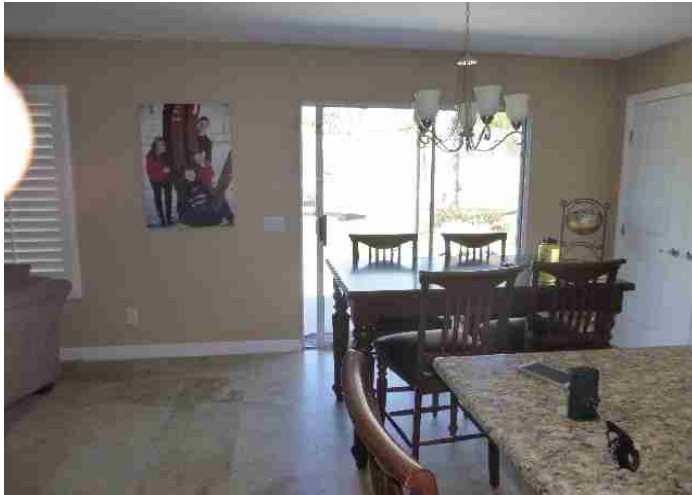
The sliding screen door is missing.

The sliding screen door is missing - *Continued*

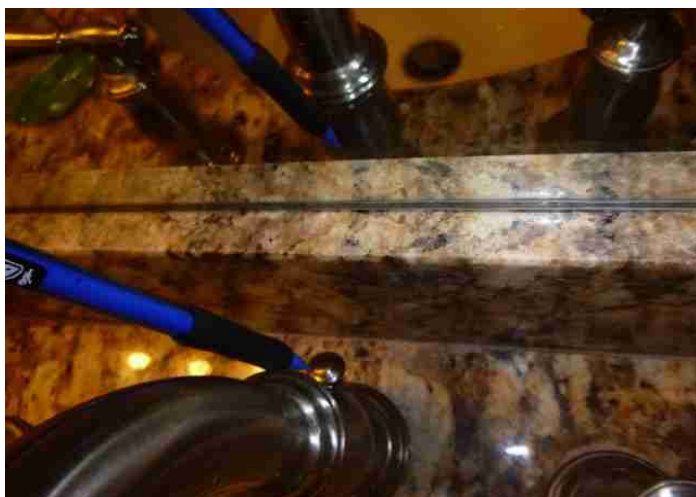
The pop up drain is not connected properly to the faucet. A licensed plumber is recommended.

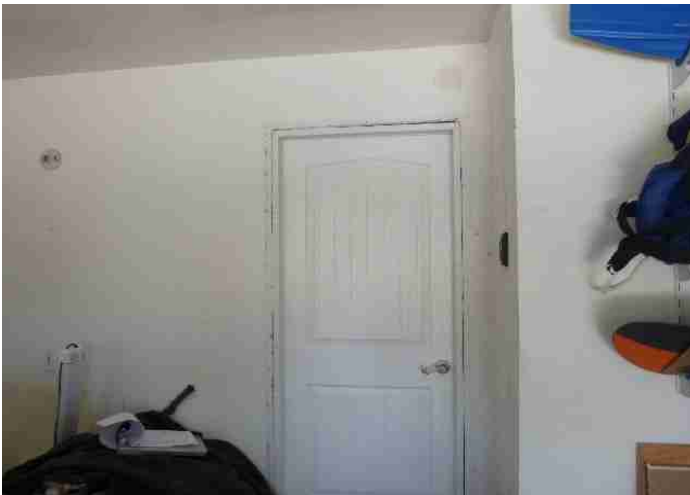
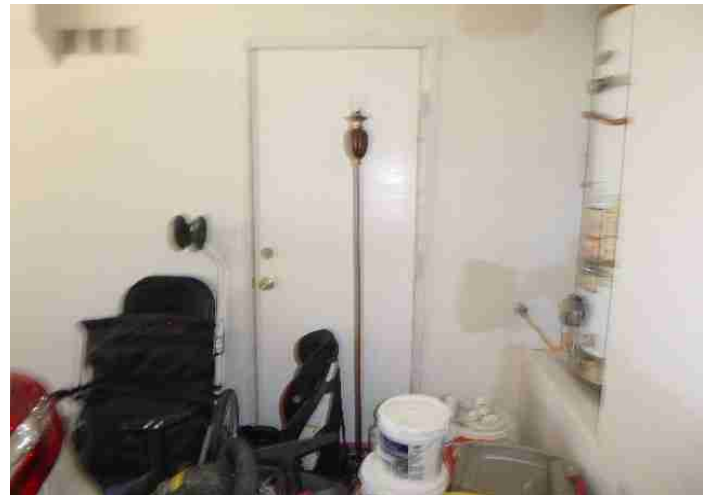
There is evidence of moisture intrusion in the garage. However, it is not uncommon to find such evidence in the form of efflorescence, or salt crystal formations, on the walls and slab of a garage. Garages are built on-grade, and most will be subject to some degree of moisture intrusion when it is raining. In spite of this, many older garages will not have a moisture barrier beneath the slab and, if they are below grade, the walls may not have been treated to resist moisture. However, you may wish to ask the sellers about this condition or have it evaluated by a grading and drainage contractor.

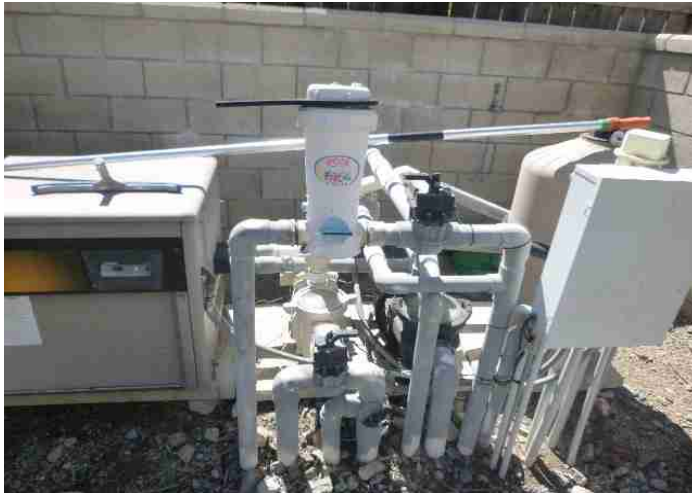
The spa and pool motor and equipment are functional but recommend a licensed pool contractor for further evaluation.
